S-188 Bowland Farm Near Kingston Private

## Survey No. S-188

## Maryland Historical Trust State Historic Sites Inventory Form

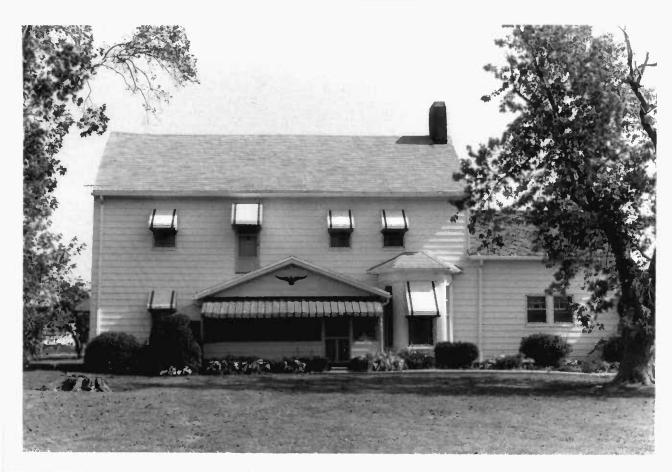
Bowland Farm
Near Kingston, Somerset County
South Elevation
9/83 Paul Touart
Neg./Md. Historical Trust

The main four-bay facade has two center doors opening into separate rooms along with another door on the second floor which used to open onto a flat roofed porch. Six over six sash windows occupy the remaining openings except for a single story bay window to the right of the front door. The porch is a recent alteration with its gable-front roof.

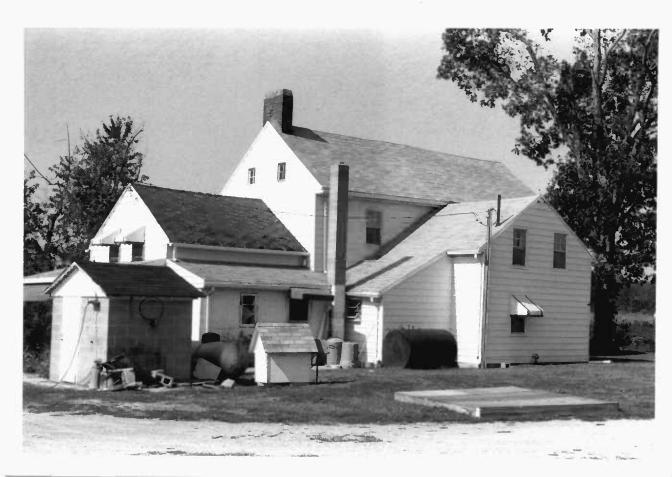
Near Kingston, Somerset County North Elevation 9/83 Paul Touart

The north facade of the main house is primarily covered by the story-and-a-half bedroom wing.
